Milwaukee County Committee of the Whole Public Hearing February 24, 2016

The Domes in Mitchell Park Conservatory

File # 16-136

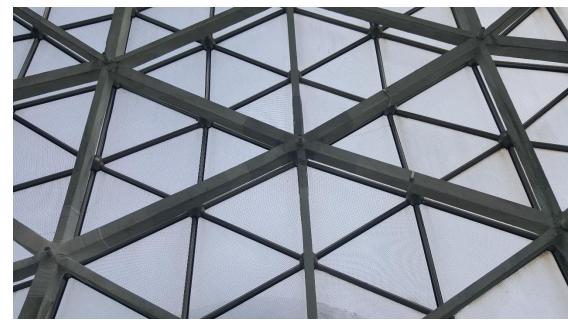
5,100 Hub Connections 1,700 Per Dome

<u>'Beehive' vs. Geodesic</u>: Geodesic domes typically do not entail concrete frame with steel base plates.

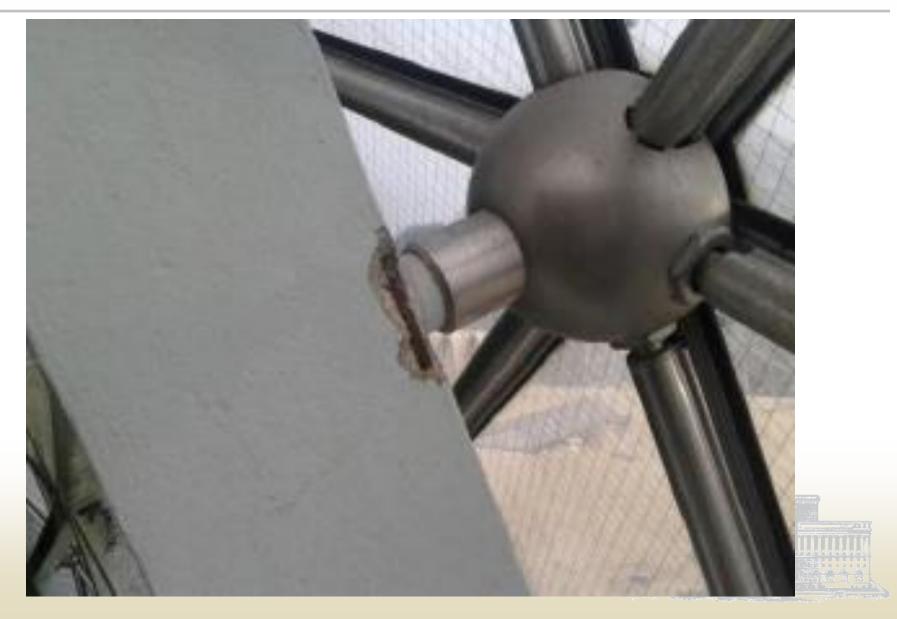
Aluminum / Concrete Hub Connection

3. ~5,100 Hub Connections (aluminum to concrete frame)

- Each a point of potential corrosion and spalling due to steel baseplate.
